ELASTIC PITCH BEAM TAIL ROTOR OPERATIONAL  
SUITABILITY INVESTIGATION

Kaman Aerospace Corporation

Army Air Mobility Research and Development  
Laboratory

July 1974

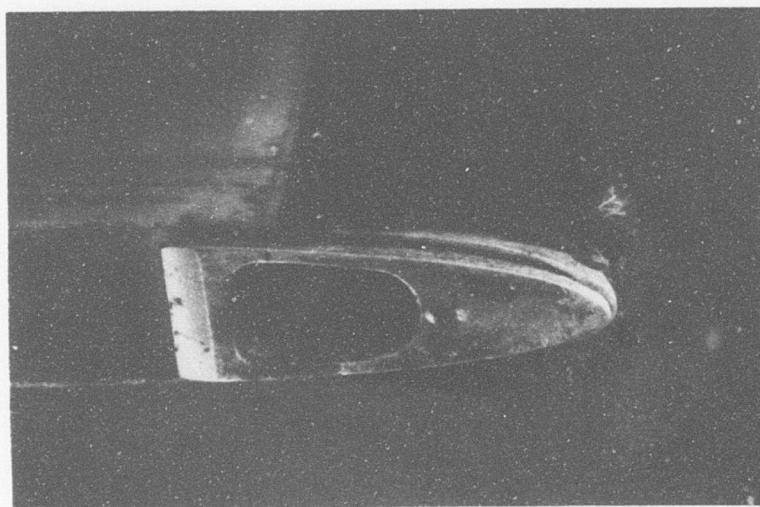
Figure 43. Condition of A-Blade After Severing 5/8-Inch Maple Dowel in Run 8. (Dowel caused damage to erosion boot, slight dent in aluminum leading edge approx 1/8 inch in depth, and opened .015-inch gap between leading edge and ballast block.)

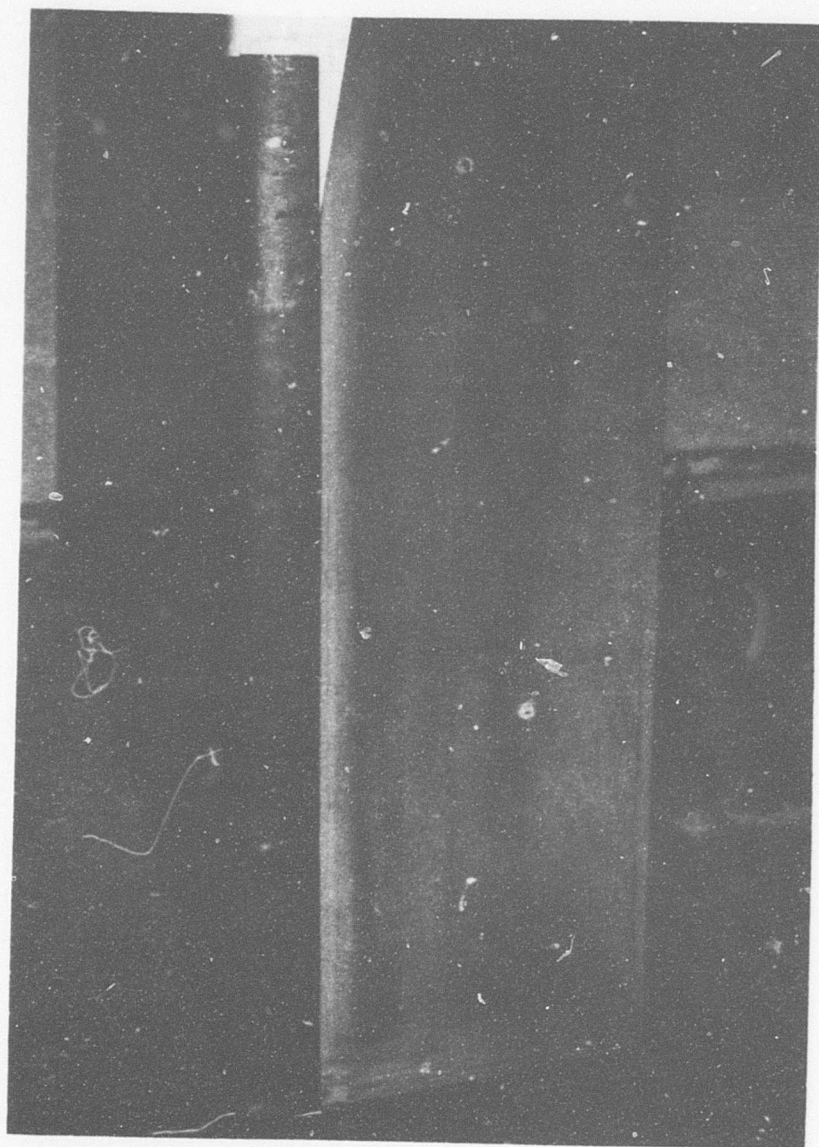
Figure 45. Ballistic Damage to A-Blade From 7.62mm Ball - Entry Side of Bullet. (Two outboard hits inflicted just prior to Run 9. Inboard hit made prior to Run 6. Shot through erosion guard and .050-inch aluminum leading edge caused localized boot unbonding. Shots through fiberglass skin to core created no damage other than hole.)

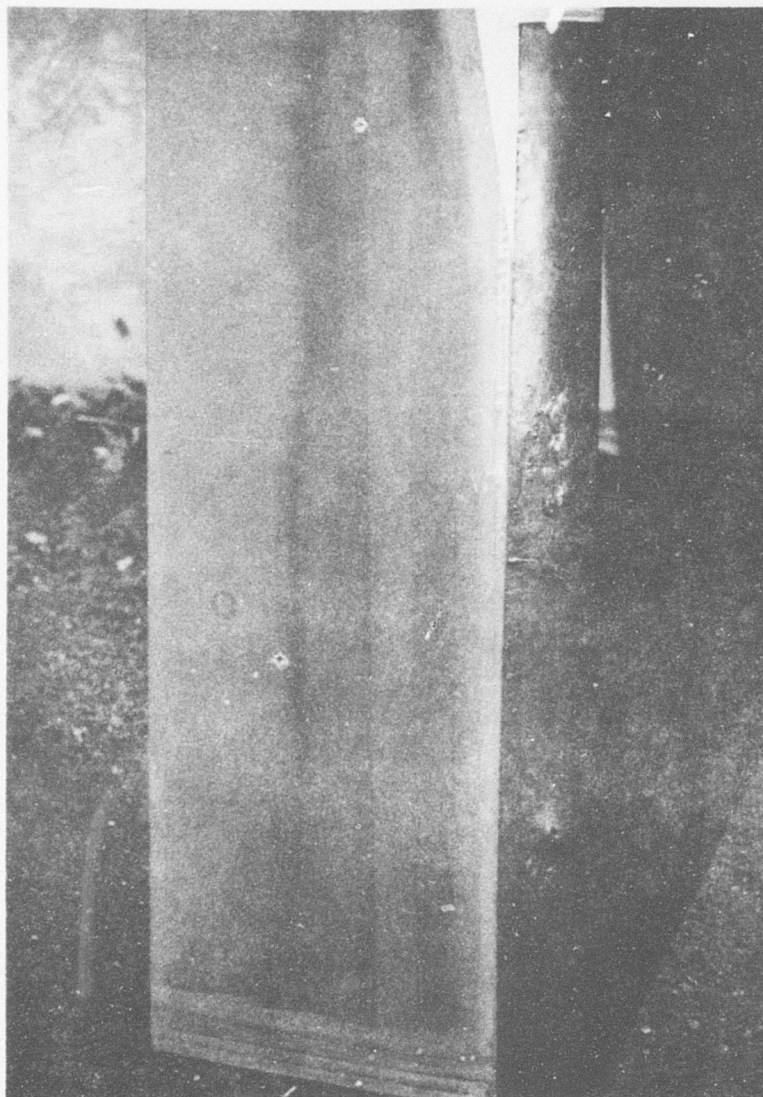
Figure 46. Ballistic Damage to A-Blade From 7.62mm Ball - Exit Side of Bullet. (Same hit as Figure 45. Bullet created a uniform cone-like projection hole on exit.)

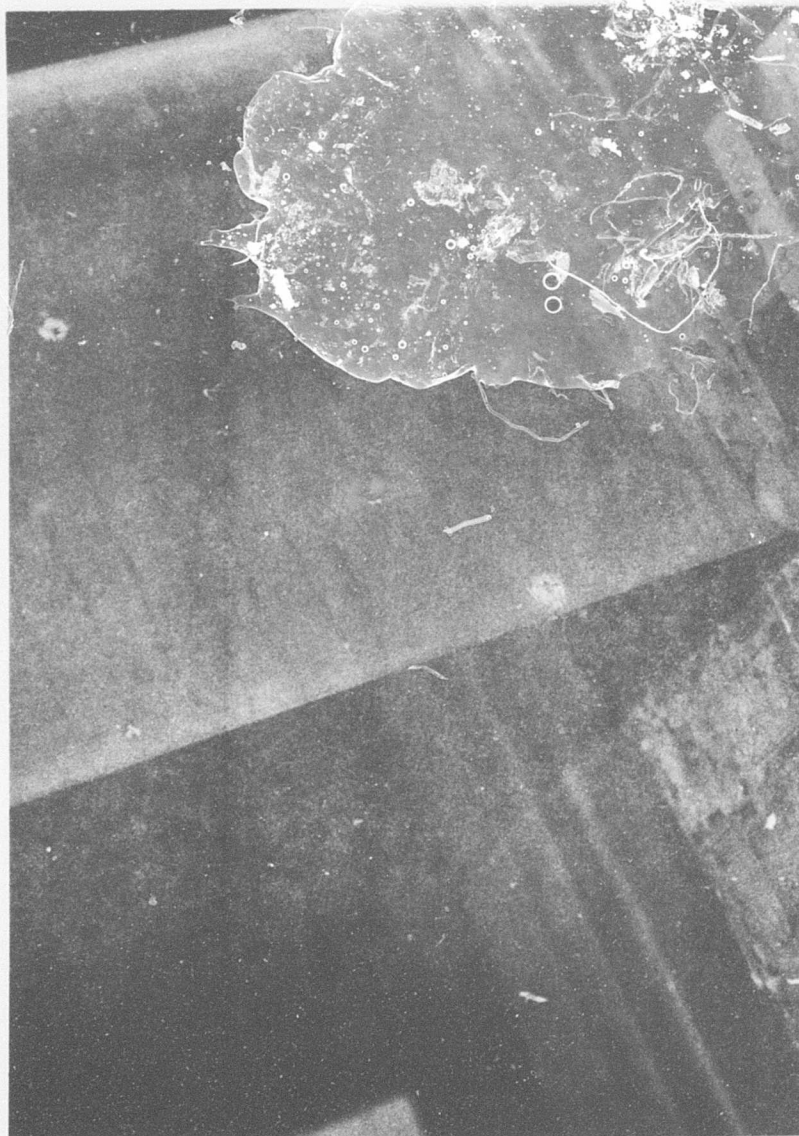
Figure 47. Ballistic Damage to B-Blade From 7.62mm Ball - Entry Side of Bullet. (Hit through fiberglass skin to core inflicted prior to Run 6. Shot through fiberglass skin to fiberglass spline occurred prior to Run 9.)

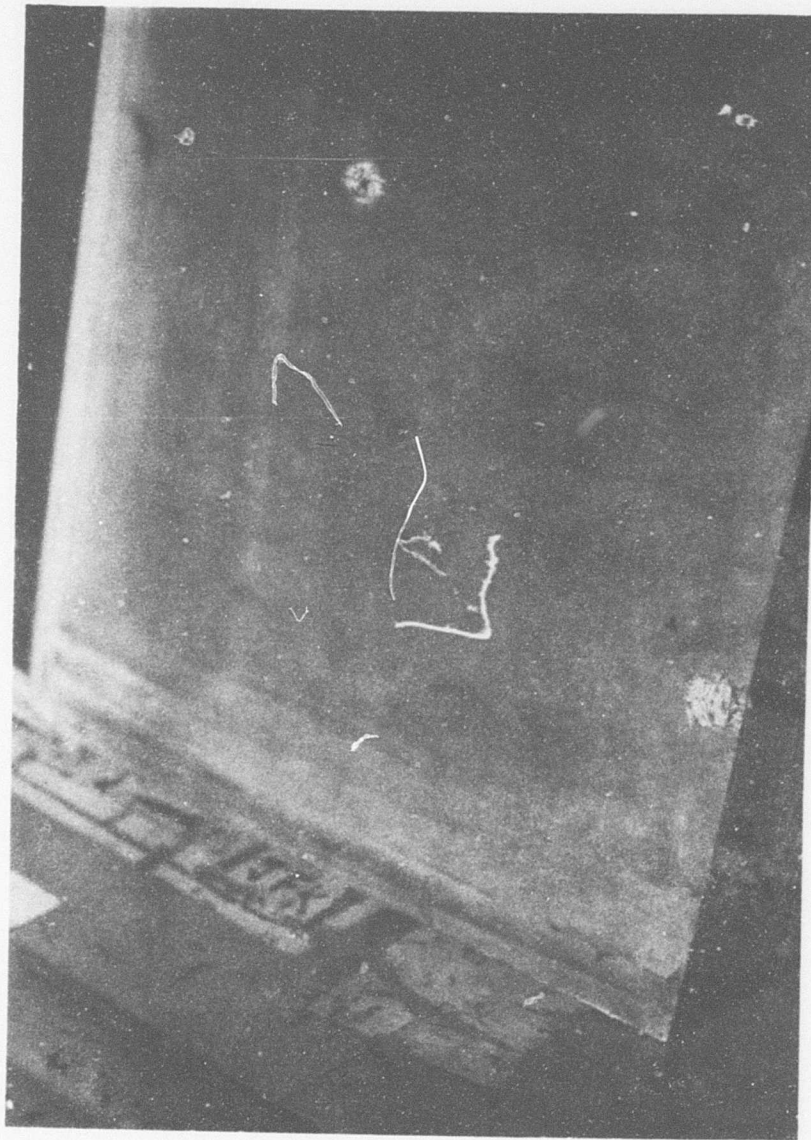
Figure 48. Ballistic Damage to B-Blade From 7.62mm Ball - Exit Side of Bullet. (Extent of damage other than hole was a 7/8-inch-diameter skin delamination around hole through spline as evident. Delamination opened to trailing edge for 5/8-inch length.)

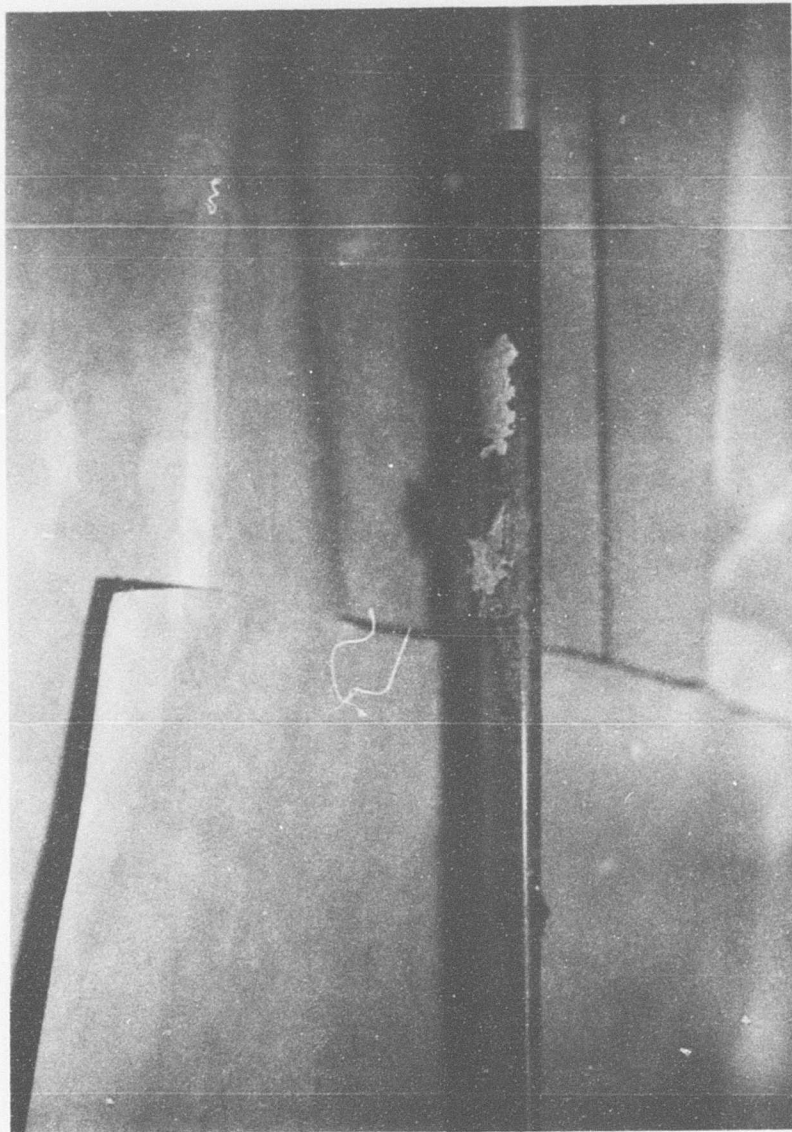
Figure 53. Condition of A-Blade From Gravel Impingement After Termination of Run 12. (Only lower break in erosion guard caused by Run 11 testing.)

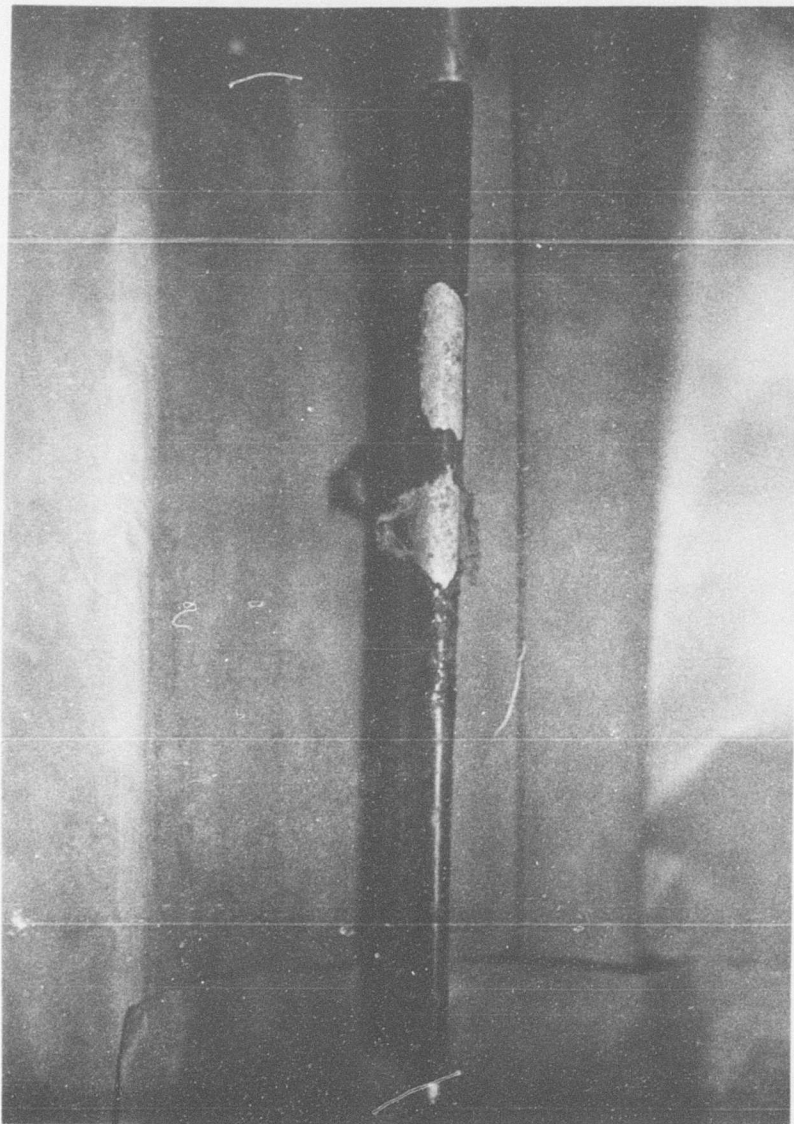
Figure 54. Condition of B-Blade From Gravel Impingement After Termination of Run 12. (Only lower break in erosion guard caused by Run 11 testing.)

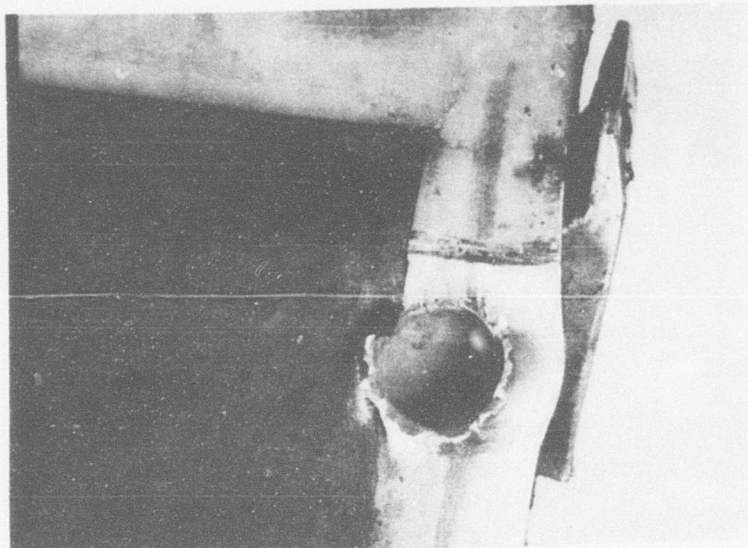
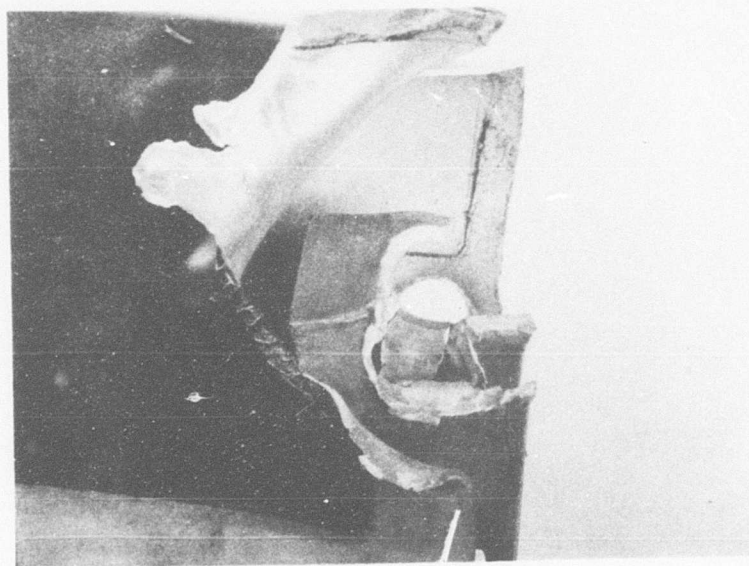
Figure 55. Ballistic Damage to B-Blade at Outboard Ballast Weight Region From 7.62mm AP Hit. (Entry side, top view. Exit side, lower view.) (Leading-edge section of aluminum ballast weight severed by the hit. No bond delamination experienced.)

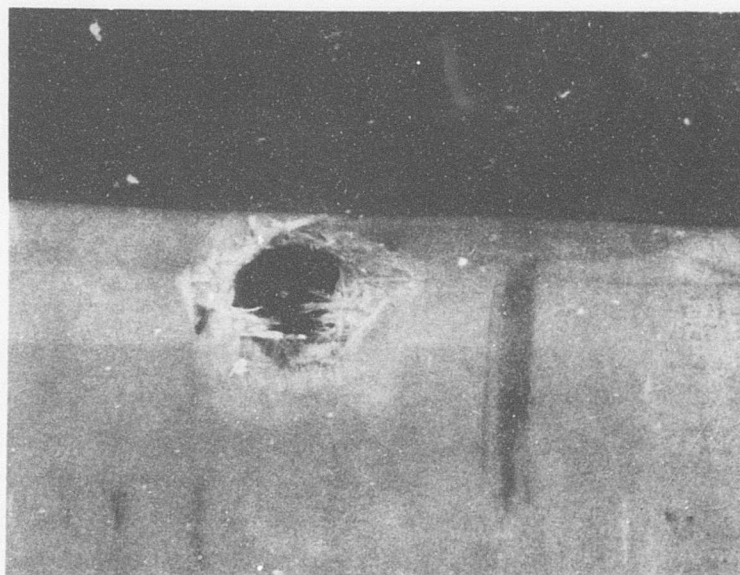
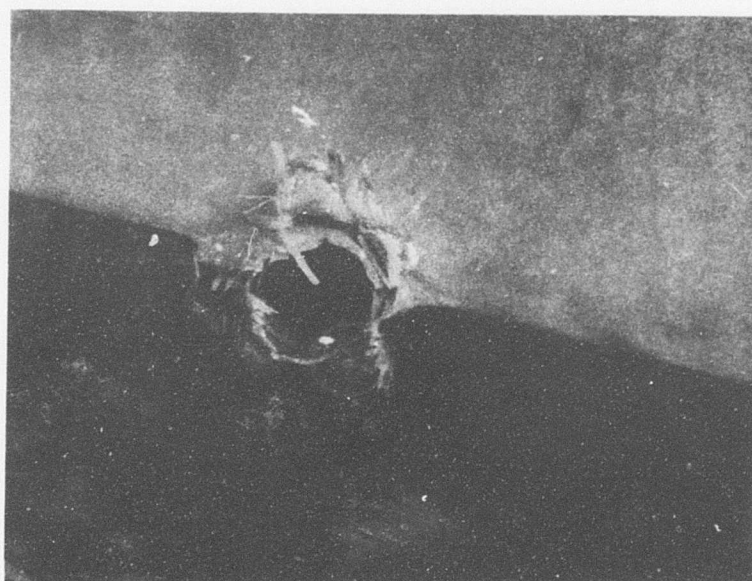
Figure 56. Ballistic Damage to B-Blade at Station 37.5 From 7.62mm AP Hit Through Forward Channel Section. (Bullet entered top surface as shown in upper view, penetrated through spar, and exited from bottom side as shown in lower view.)

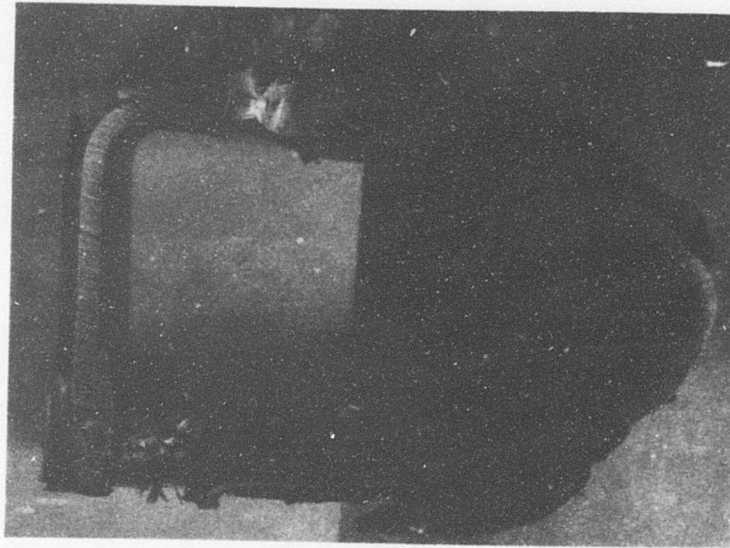
Figure 57. Sectioned View Through B-Blade at Station 37.5, Showing Forward Channel. (Same hit as shown in Figure 56. Bond delamination between channel to leading edge confined to immediate vicinity of hit. Delamination attributed to metal deformation rather than shock.)

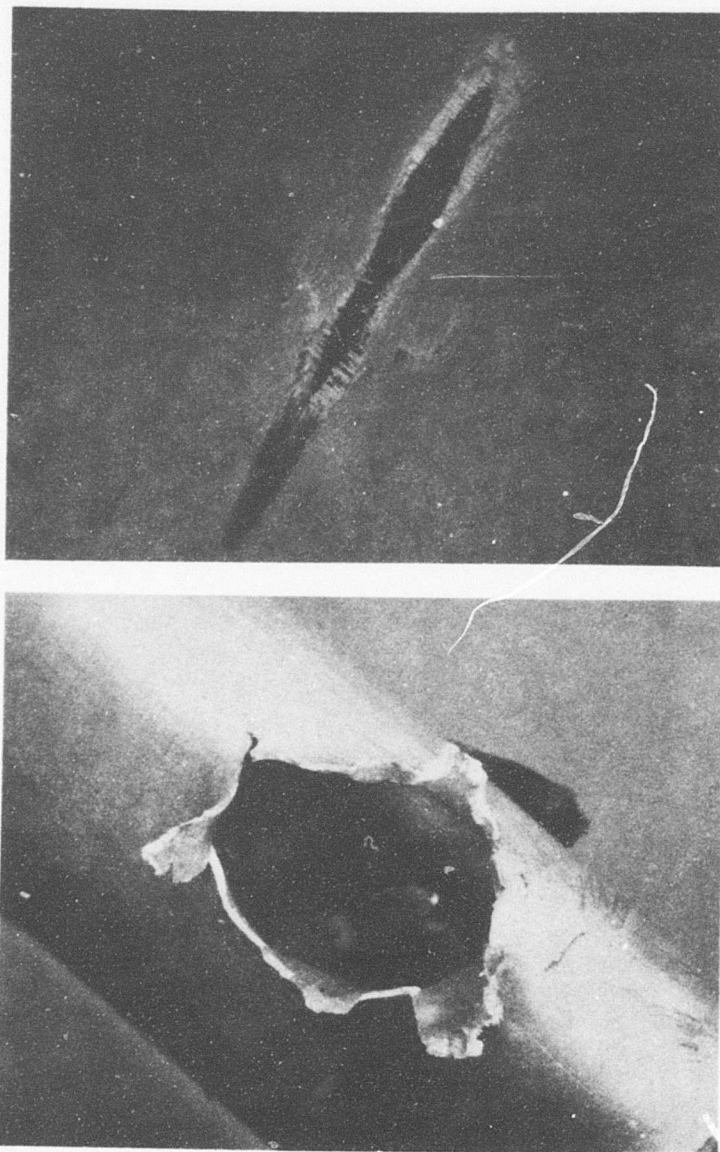
Figure 58. Ballistic Damage to B-Blade at Station 27 From 7.62mm AP Hit. (Bullet entered blade at pocket skin as shown in upper view, penetrated spar from aft face, and exited through aluminum leading edge as shown in lower view.)

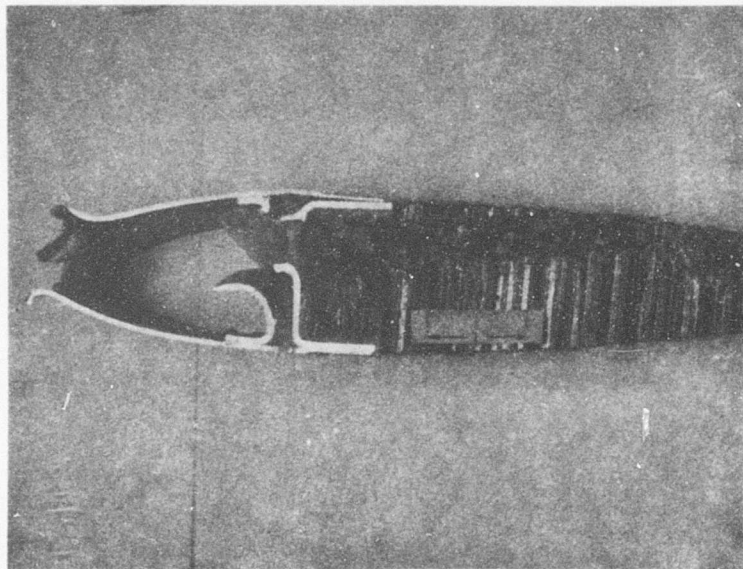
Figure 59. Sectioned View of Ballistic Damage to B-Blade at Station 27. (Same hit as shown in Figure 58. Station 27 is just inboard of the termination point for the GRP spar in the tapered section region. Delamination of bond is again localized to the damaged area and attributed to deformation rather than shock.)

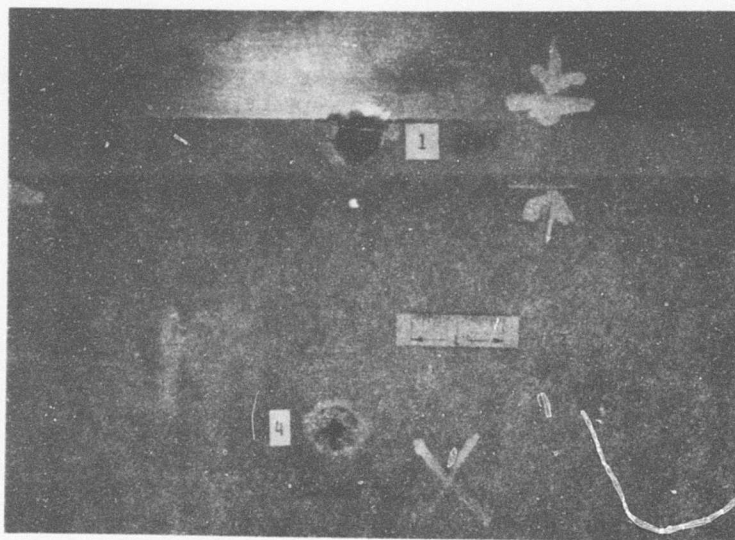
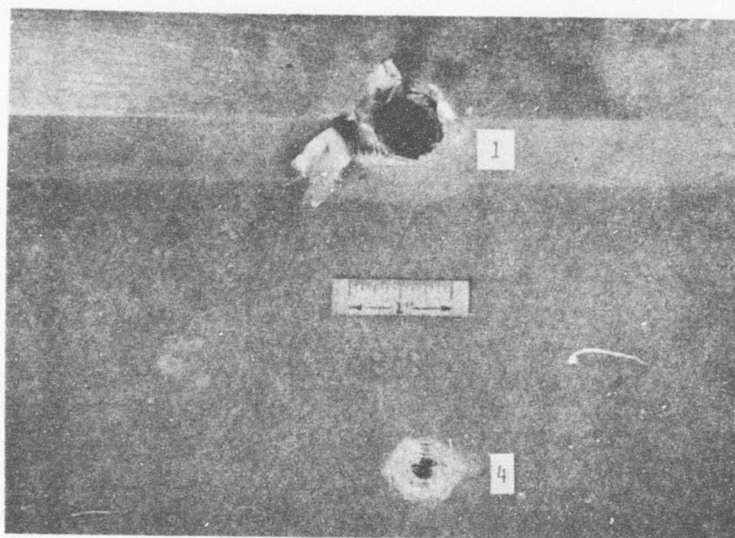
Figure 60. Ballistic Damage to Blade Section From 12.7mm AP Hits. Entry Side, Top View. Exit Side, Lower View. (Shot No. 1 is through forward channel - leading-edge section equivalent to Figure 56. Bond delamination confined to immediate vicinity of the hit and attributed to localized deformation rather than shock. Shot No. 4 through skin-core structure produced no significant damage.)

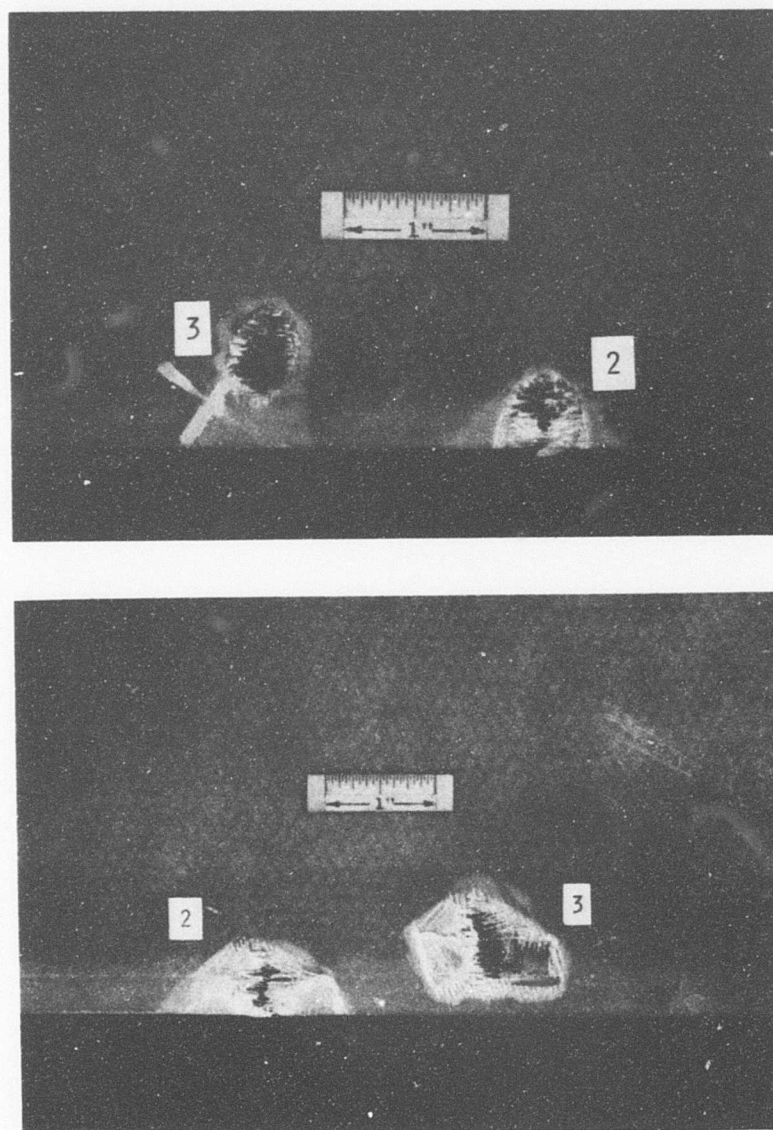
Figure 61. Ballistic Damage to Blade Trailing Edge From 12.7mm AP Hits. Entry Side, Top View. Exit Side, Lower View. (Shot No. 2 completely severed spline. Shot No. 3 just nicking the spline caused localized skin to spline delamination on entry side, but spline remained intact.)

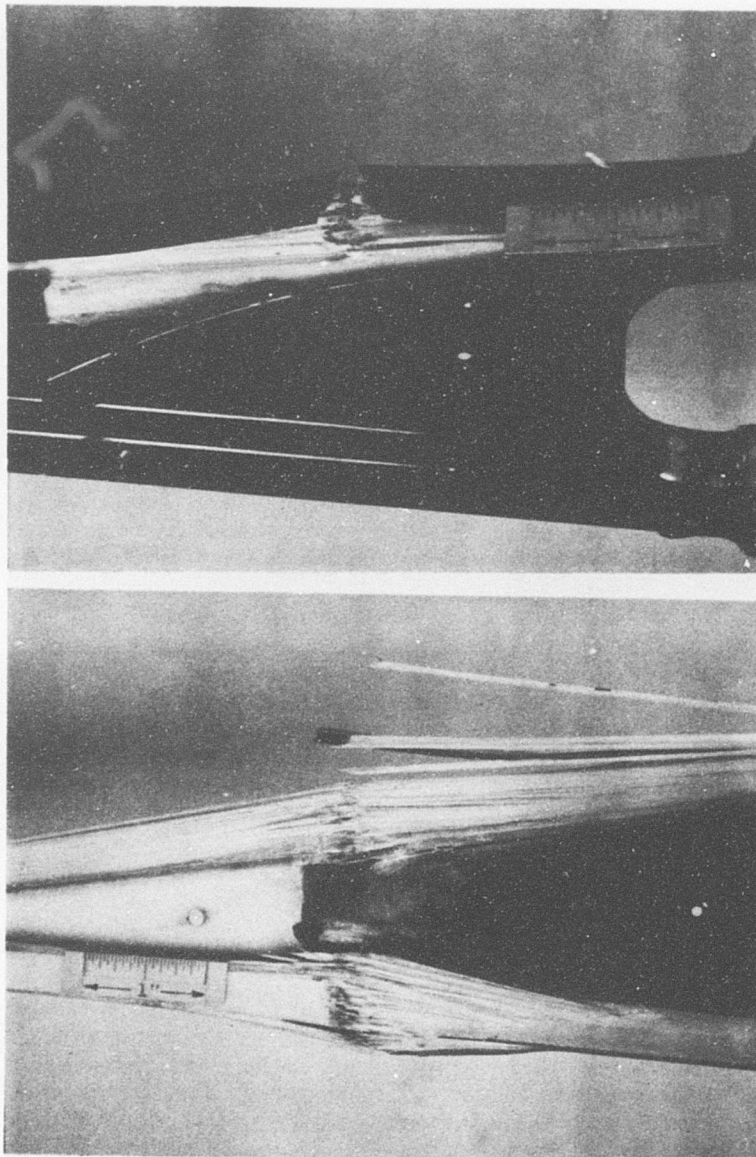
Figure 62. Ballistic Damage to Spar Component From 12.7mm AP Hits. (The upper view shows the damage to a single strap from Shot No. 5 normal to the edgewise plane severing the protective coating and fragmenting one-third of the section. The lower view shows damage to both straps from Shot No. 7 parallel to the flatwise plane fragmenting the outer layers of fibers.)

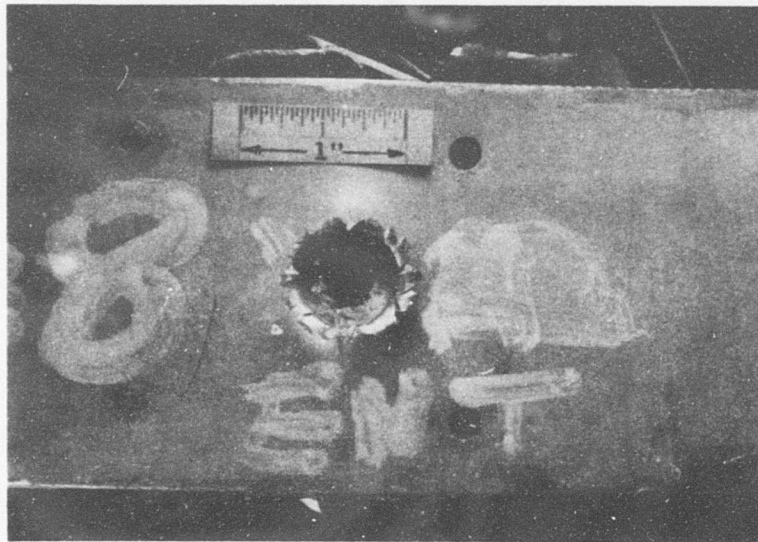
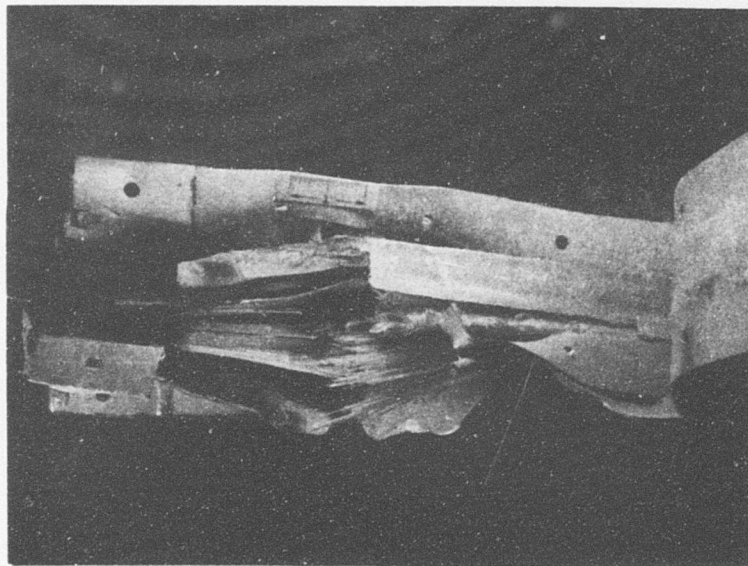
Figure 63. Ballistic Damage to Spar-Channel at Section From 12.7mm AP Hit. Entry Side, Top View. Exit Side, Lower View. (Hit directed at the bond interface between straps.)
